Floor Joint Filler Color Change

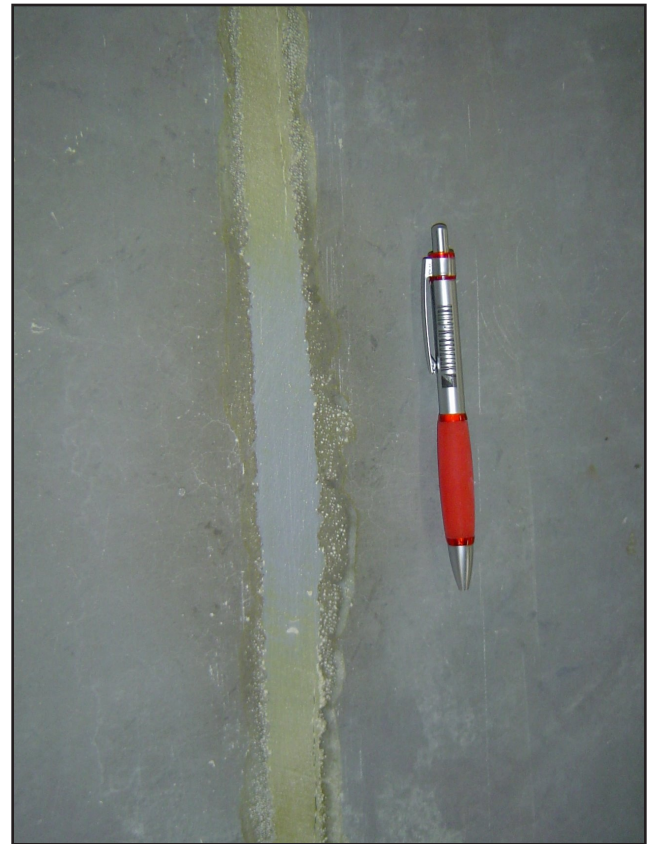
Most semi-rigid epoxy and polyurea floor joint fillers have the potential to exhibit some change in color in certain settings, and Metzger/McGuire fillers are no different. The most common color change occurrence is when a gray filler exhibits a shift towards a yellowish or green tone (see photo at right).

Certain lighting systems can emit UV rays within a spectrum that can actually cause discoloration of the filler or which simply render the filler's gray color more green or yellow in tone. This phenomena has occurred with far more frequency in the past ten years as lighting system manufacturers have tried to produce more energy efficient lamps.

Photo above shows yellowing of the gray joint filler caused by the lighting system. The center of the joint was lightly sanded to show original filler color.

The easiest way to confirm whether the lighting system is responsible is to dispense the same filler in an area that is not subject to the same lighting. If there are no such unlighted areas, dispense the filler on cardboard and promptly shade it from the lighting source. Monitor it for color stability for 1-14 days, then remove the covering. If there are clear differences between the light exposed placement and the covered sample, then lighting can be identified as the cause.
