Joint Filler Protrusion in Exposed Concrete Floors

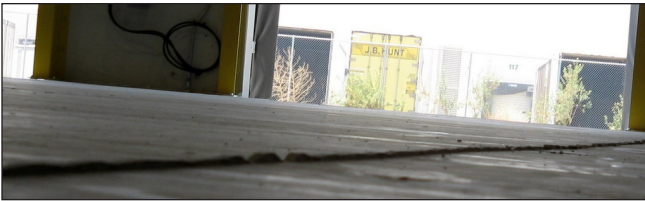
When floors expand, the difference can be measured at the joints. The same joint can be 1/4" (6.35 mm) wide in December and 1/8" (3.17 mm) wide in July. You will generally not notice the joint width change if the joints are not filled. But if the joints are filled, you can tell immediately how much the slab has expanded or contracted.

Ex. of Filler protrusion in building with no climate control

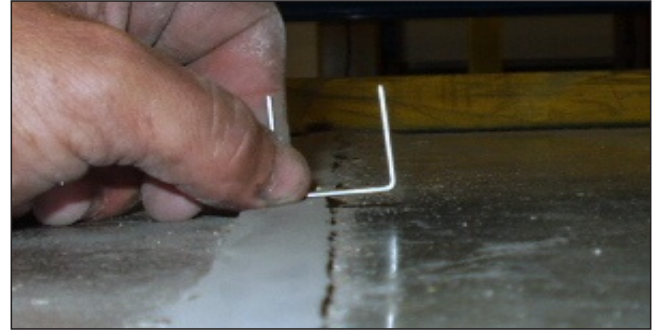
On many projects the joints are filled before the HVAC is turned on. If the joints are filled while the ambient temperature is cool, and then the heat is turned on, the increase in temperature can cause slab expansion, which in turn causes joints to narrow, causing filler extrusion.

Example of filler protrusion in exposed floor

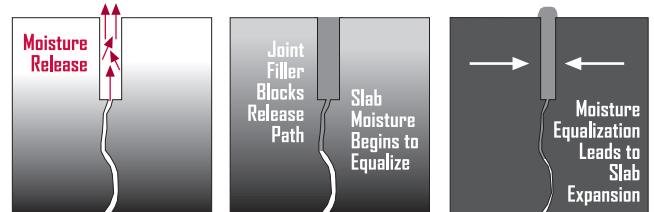
Surface sealers and liquid hardeners/densifiers can reduce moisture evaporation through the slab surface. Once the joints are filled, the slab moisture is essentially trapped. As the moisture within the slab equalizes, moisture migrating to the upper portion can cause slab expansion, which in turn can cause filler compression.

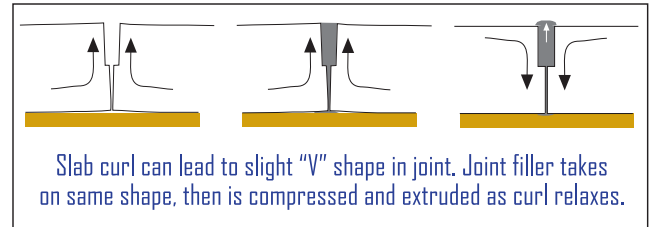
Filler Extrusion Caused By Relaxation Of Curled Edges

All slab panel edges curl to some degree (see [Technical Bulletin T15](#)). When edges curl they lift upward and back away from the joint, causing the joints to become slightly "V" shaped. If curl is relaxed (due to an increase in upper slab moisture content, higher humidity at surface level, etc.) the joint walls can once again become plumb and parallel (eliminating the "V" shape), potentially causing joint filler compression and protrusion.
