Filling Joints in Curled and Rocking Slabs

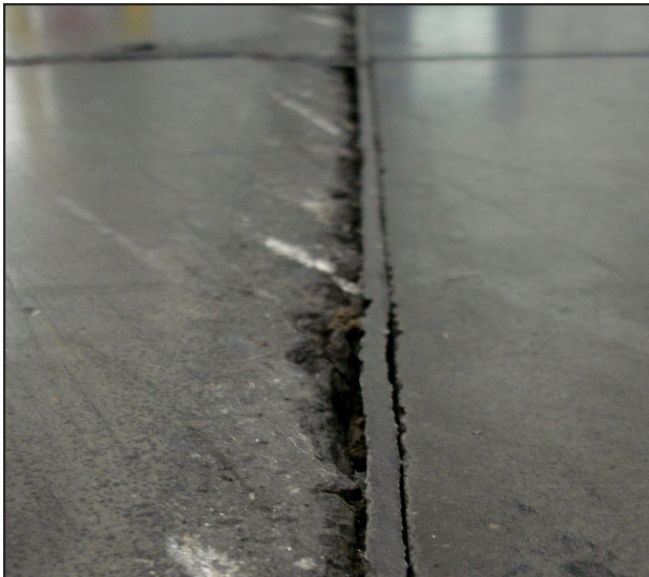
Exaggerated profile view of the slab curl phenomena

Curled slab panels create impact points for material handling vehicle wheels and joint edges along curled panels can quickly deteriorate if left uncorrected.

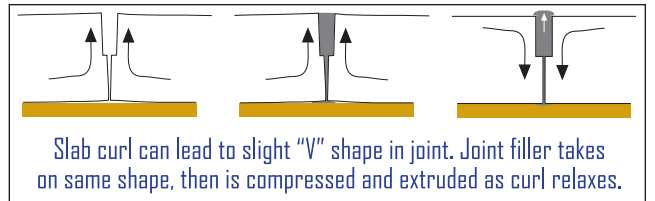
In some cases slab edge curl may relax, and the slab will return to its original position. Should this occur the joint filler may be compressed and literally extruded upward with its top above the floor surface.

Slab curl can lead to slight "V" shape in joint. Joint filler takes on same shape, then is compressed and extruded as curl relaxes.

Slab curl and/or rocking affects on joint fillers.

No semi-rigid joint filler can remain effective as an edge protector if slabs are significantly curled or are rocking. If rocking or slab curl conditions are detected on a project prior to the start of joint filling work we recommend that filling be delayed until the effect of the curl/rocking conditions on the joint filler and the durability of the floor and potential correction methods can be discussed by all involved parties.

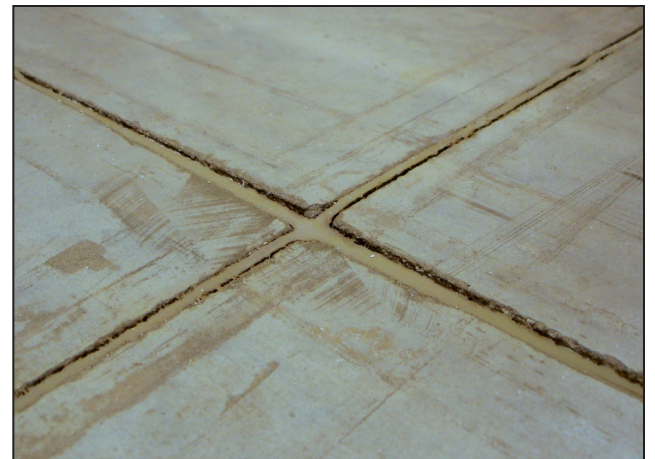
panel deflects as a load is imposed, the adjacent slab remains in its original higher position, and thus the joint edge is vulnerable to hard wheel impact and spalling. Even without wheel impact, the semi-rigid joint filler's protection will be compromised as it shears away from its bond to the joint walls.

Curled or rocking slab panels can compromise the ability of the filler to provide proper edge protection.

Please contact Metzger/McGuire for more detailed information on the correction/repair of slab curl or rocking slab panel conditions.
