Identification and Correction of Deficient Work

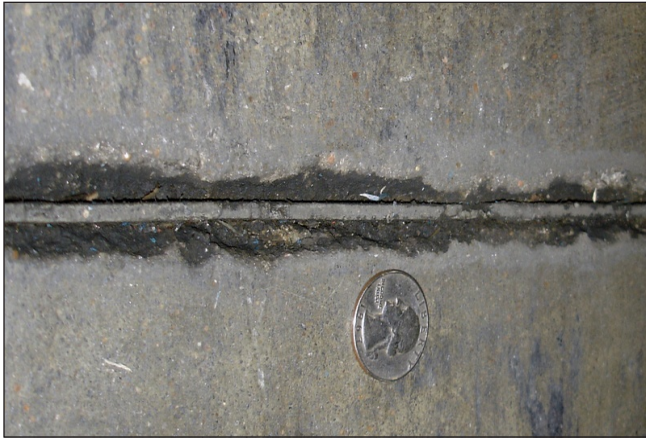
Shallow Filling

To be effective as a joint edge protector a semi-rigid filler must rest on the shelf at the base of the saw cut or be well adhered to the joint walls at least 2" (50 mm) deep to compensate for the lack of base support.

Indication: The most obvious sign of less-than-proper filler depth is when the joint filler is depressed below the surface of the floor or falls into the joint after opening occurs.

Correction: Remove existing filler completely, clean joints properly as outlined in Metzger/McGuire Installation Guidelines and refill properly.

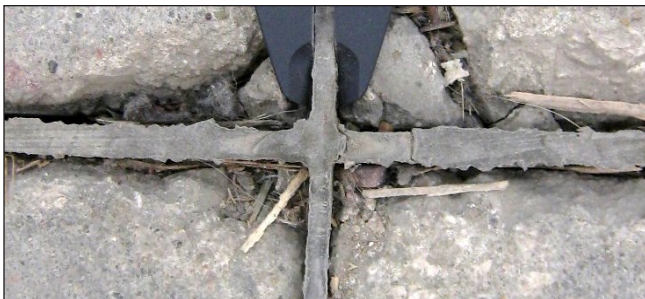
Note: Joint edges may have deteriorated (spalled) as a result of hard-wheeled traffic crossing the inadequately protected joint. If spalling has occurred refer to Metzger/McGuire's *Guide to Basic Floor Repair* for standard spalled joint repair details.

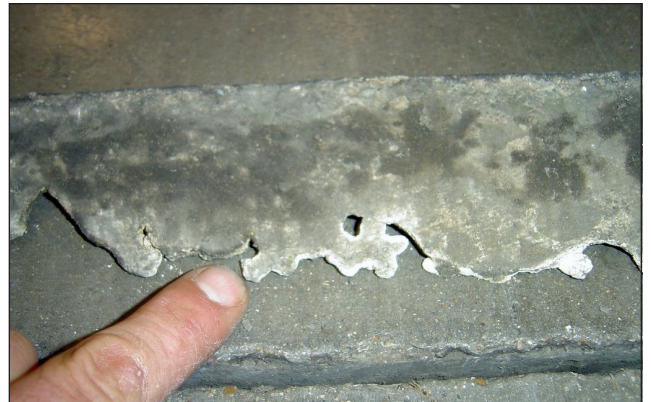
Inadequate Joint Cleaning

Dry-cut sawing is the best means of achieving a clean joint. If debris or residue from sealers, etc. remain on the joint walls, filler-to-wall adhesion can be compromised.

Indication: Improper cleaning is detectable by inspecting the sides of cured filler removed from the joint. If dirt or debris are embedded in the filler, inadequate cleaning is indicated.

Correction: Remove existing filler completely, clean joints properly as outlined in Metzger/McGuire Installation Guidelines and refill properly.

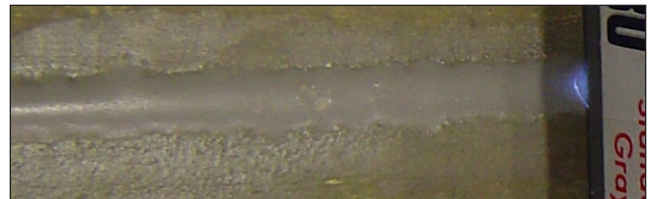
Concave Material Profile

To be effective as a joint edge protector finished filler profile must be flush with the floor surface and provide a smooth, interruption-free transition across the joint. A concave or "dished" filler profile leaves joint edges exposed as impact points and thus subject to deterioration under hard-wheeled traffic.

See *Technical Bulletin T8* for discussion of indications and correction of low profile filler.
